October 15, 2018
GZA File No: 01.00171521.52

Re: Immediate Response Action Plan
Turbid Outfall Discharge
(Former) Everett Staging Yard
One Broadway
Everett, Massachusetts
Release Tracking Number 3-35119

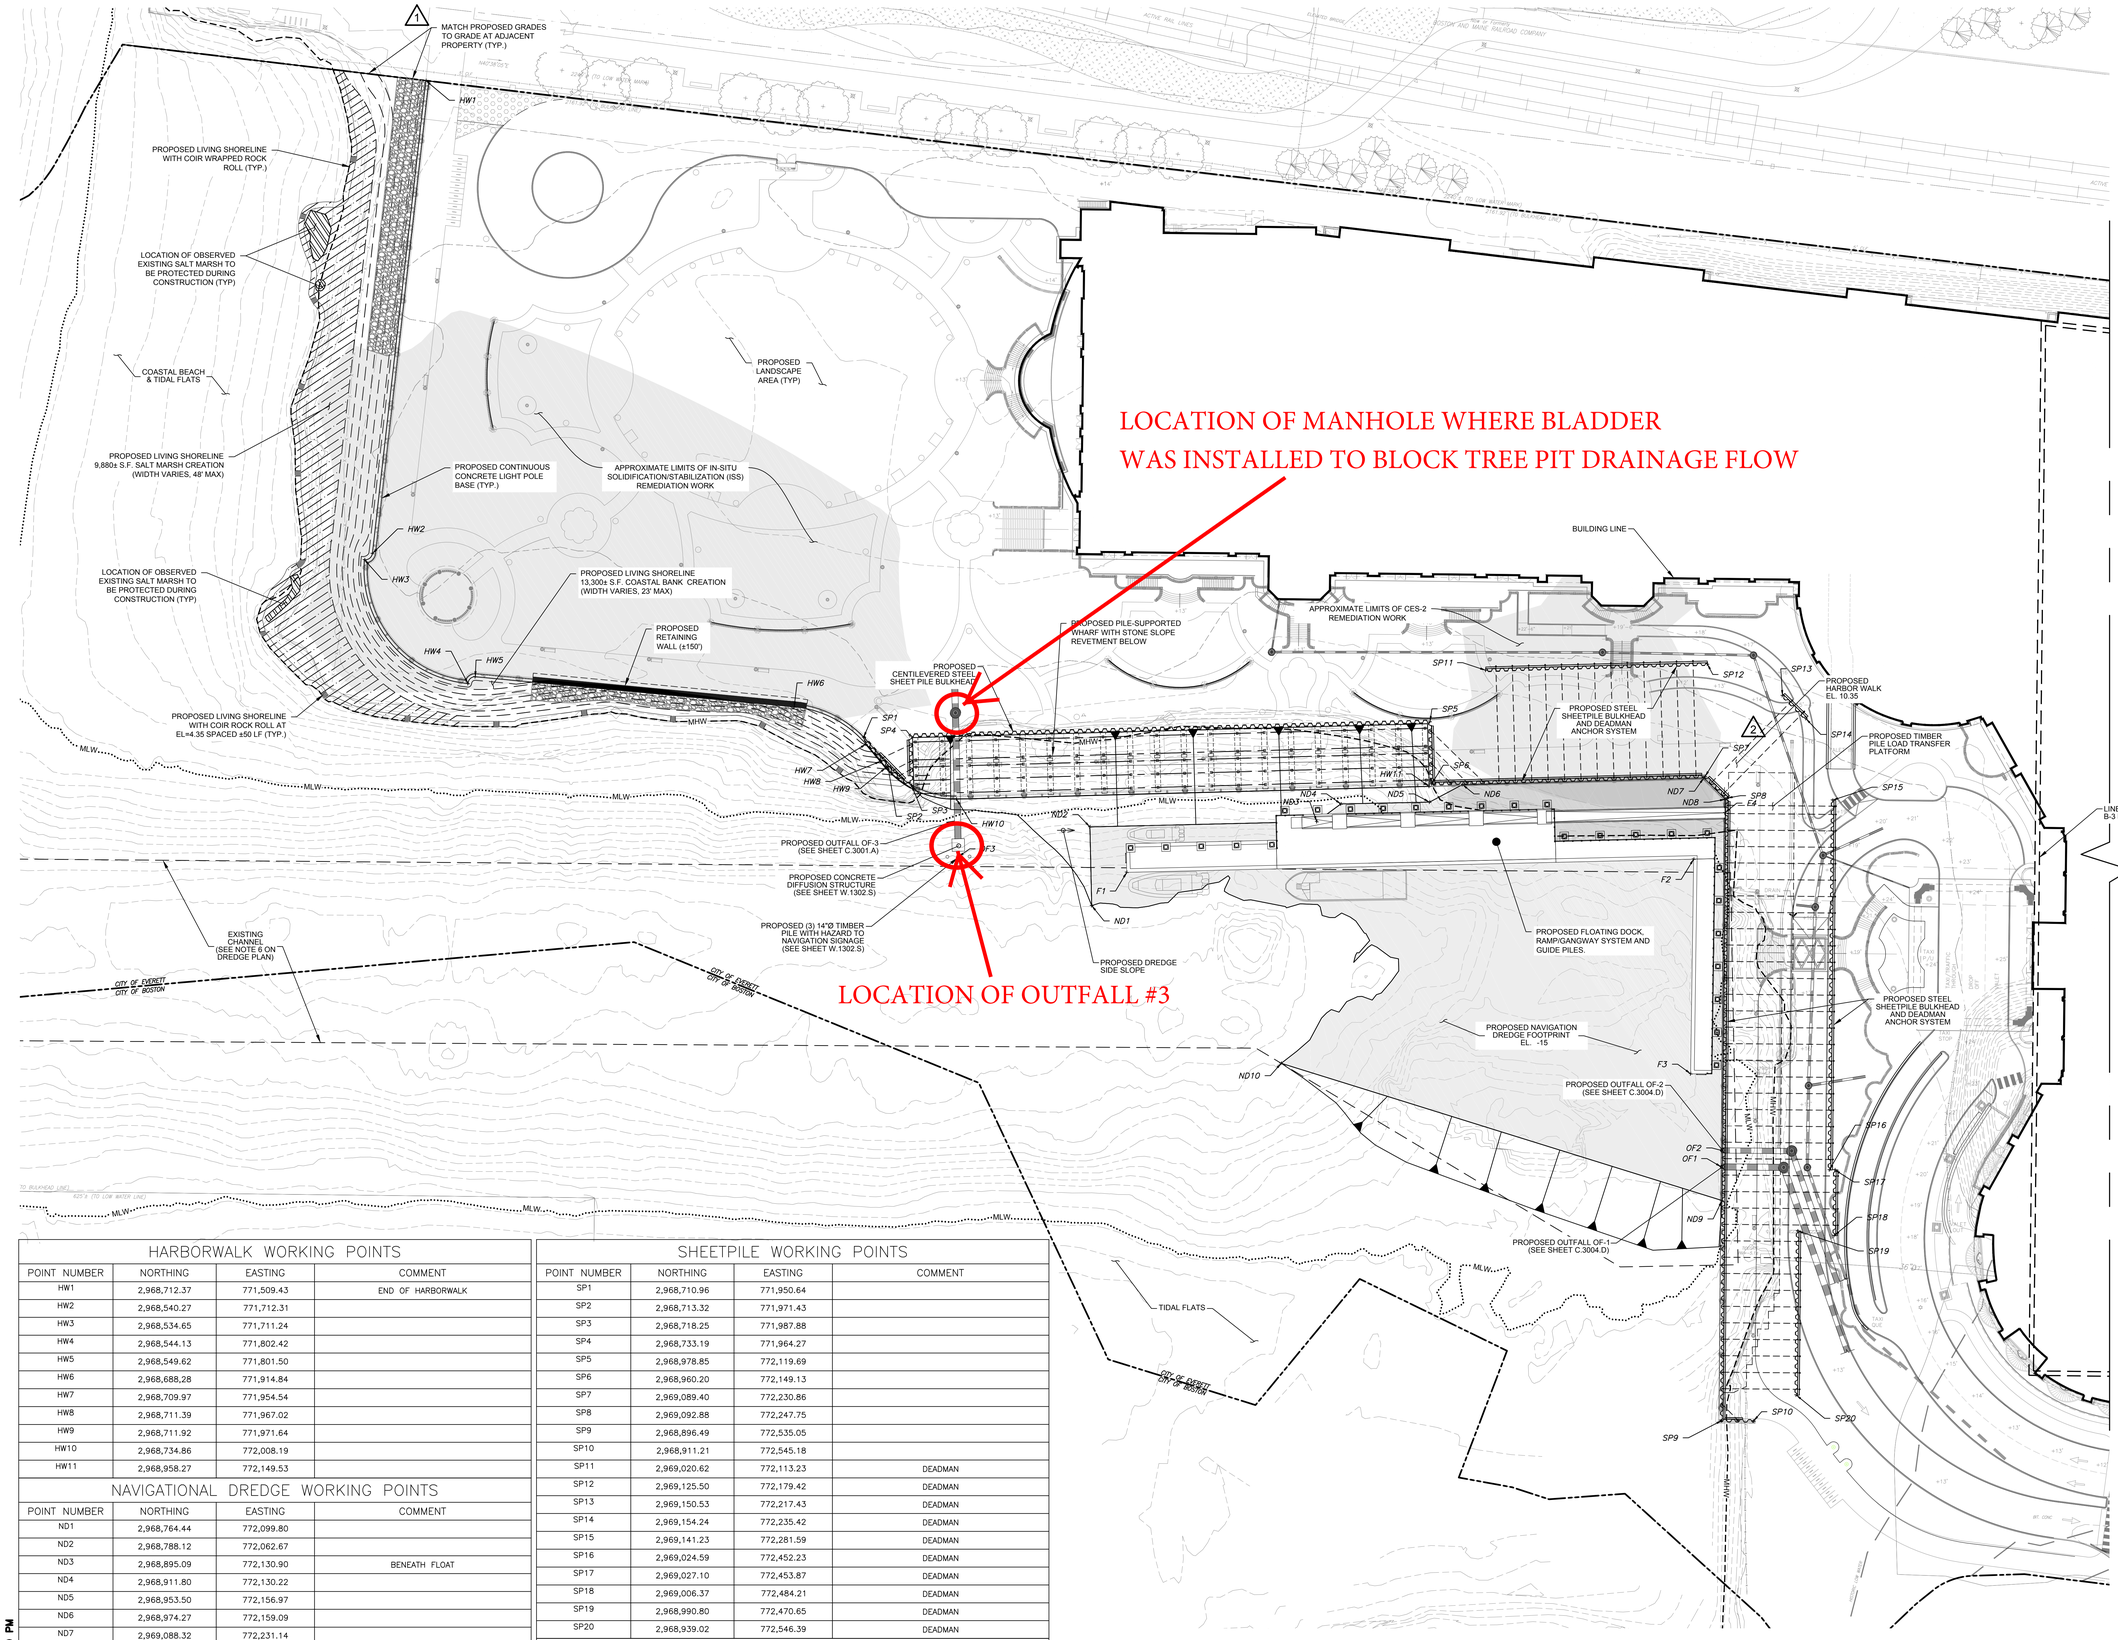
The IRA disposal site is a small portion of the Disposal Site at One Broadway in Everett (the "Property;" Figure 1). The location of the observed turbid discharge is shown on Figure 2. The approximate latitude and longitude for the location of the turbid discharge is 42.3935 degrees north and 71.0710 degrees west, respectively. The Universal Transverse Mercator (UTM) coordinates are 4,695,549 meters north and 329,535 meters east. Access to the Property is limited by the presence of a chain-link fence with two security gates that are manned 24 hours a day, seven days a week; one gate is in the northern portion of the Property, west of the adjacent MBTA property (as described below), and the second gate is located on the eastern side of the Property proximate to the former Horizon Way. A resort casino building is under construction on the Property; the surrounding ground surface at the Property is generally bituminous pavement, landscaped, or compacted coarse gravel. The ground surface at the Property is currently highest proximate to the resort

casino building, and slopes downward from that area to the east and south towards the Mystic River. Current ground surface elevations at the Site, based on the NAVD 88 datum, range from 15 feet (proximate to the building) to elevation 10 feet proximate to the top of the Coastal Bank. Grades slope downward to about elevation 4.35 feet from the top of Coastal Bank to the bottom of the living shoreline. The observed discharge of turbid water emanates from Outfall #3 at approximately elevation -6.0 to -7.0 feet.
